Mobile Intel[®] Pentium[®] 4 Processor-M

Specification Update

March 2004

Document Number: 250721-021

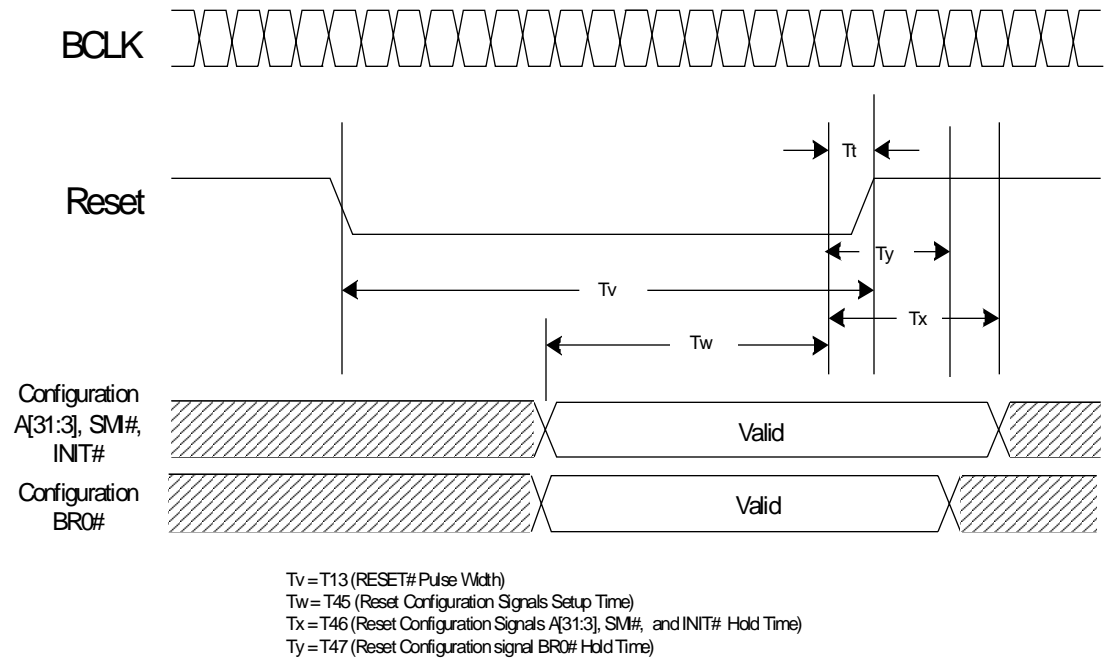
Figure 13. System Bus Reset and Configuration Timings

The BR0# maximum hold time has changed to 2 BCLKs. This change will be shown in the “System Bus AC Specifications (Reset Conditions)” table and “System Bus Reset and Configuration Timings” figure of the *Mobile Intel® Pentium® 4 Processor - M Datasheet*. This change will be incorporated in the next revision of the datasheet.

The following figure will be modified to reflect this change:
